RCRA Inspection Report

Veolia ES Technical Solutions, LLC
2176 Will Suitt Road
Creedmoor, North Carolina 27522
EPA ID No.: NCD 986 171 189

September 17, 2014, at 9:00 a.m.

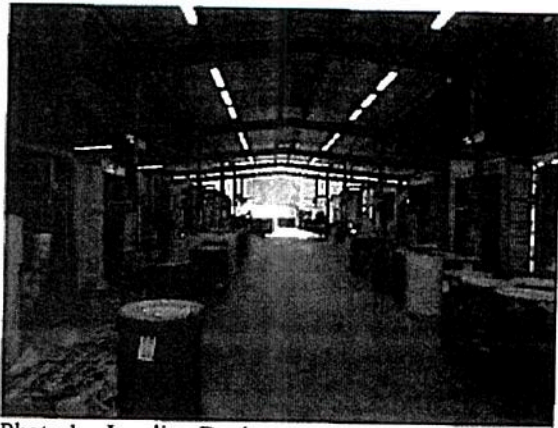
During the inspection, the inspection team noted numerous containers on the surface of the dock between the storage trailers. This area is not included in the permitted storage area for the facility. Veolia clears this area every night and does not store hazardous waste on the dock. Veolia may want to consider maintaining a coating on the dock to match the secondary containment requirements. If a container comes off a trailer and begins to leak, it would be advised to have this surface also be impervious.

Photo 1 - Loading Dock.

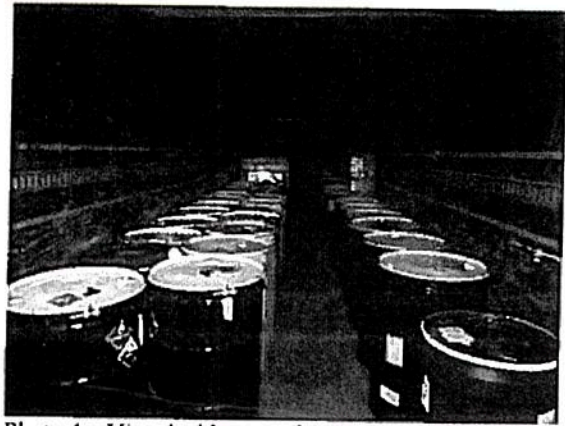
The inspection team toured each of the bays and noted dirt in one of the storage trailers. Facility representatives state that there were no procedures in place to conduct routine cleanup of these storage containers to remove dirt that may accumulated on the floor of the trailers. If a spill occurs in a trailer where dirt or trash has accumulated, the resulting mixture of dirt and trash and hazardous waste may be regulated as hazardous waste. The EPA recommends a procedure be implemented to regularly inspect and clean out trailers to ensure no containers are leaking. The inspection team also noted one cubic yard tote that was labeled on two opposite sides. There was one similar tote on one side which covered one of the container labels. If another container was placed on the other side, no container label would be visible from the aisle. The inspection team suggested labels be visible from the aisle.

Photo 4 - View inside one of the storage trailers.

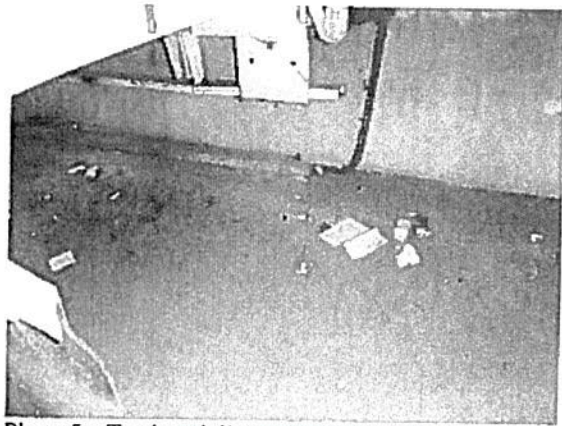
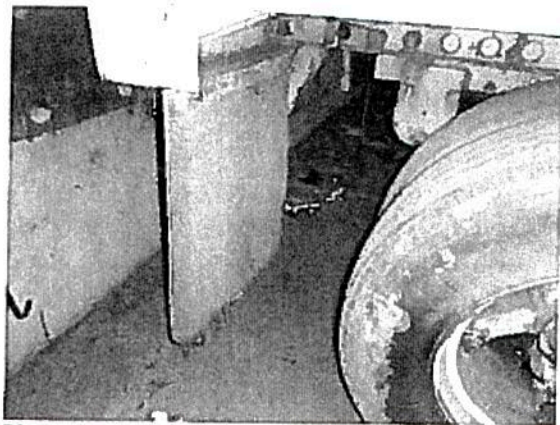
The inspection team noted trash and debris underneath many of the trailers in the storage and loading bays. Facility personnel identified this material as blown in debris and dirt (photos 5-6). Facility representatives stated that they do not open containers of hazardous waste at their facility. They did not believe the material under the trailers was anything but dirt and trash blown in from the sides of the loading dock.

Photo 5 - Trash and dirt underneath trailers.

Photo 6 - Trash and dirt underneath trailers.
